# www.WorkshopManuals.co.uk SERVICE BULLETIN

SERVICE BULLETIN No.: ESB-96E52-002				
		Date: 1997-04-15	<model></model>	<m y=""></m>
Subject:	ADDITION OF SRS AIR BA	G MAINTENANCE	ECLIPSE(D30) CARISMA	96-10 96-10
Group:	INTERIOR			
INFORMAT	ION	O. Kai - E.V.P. & G.M. After Sales Service Dept.

In the SRS air bag troubleshooting, items of cause of trouble in the inspection procedure for each diagnostic trouble code, have been added.

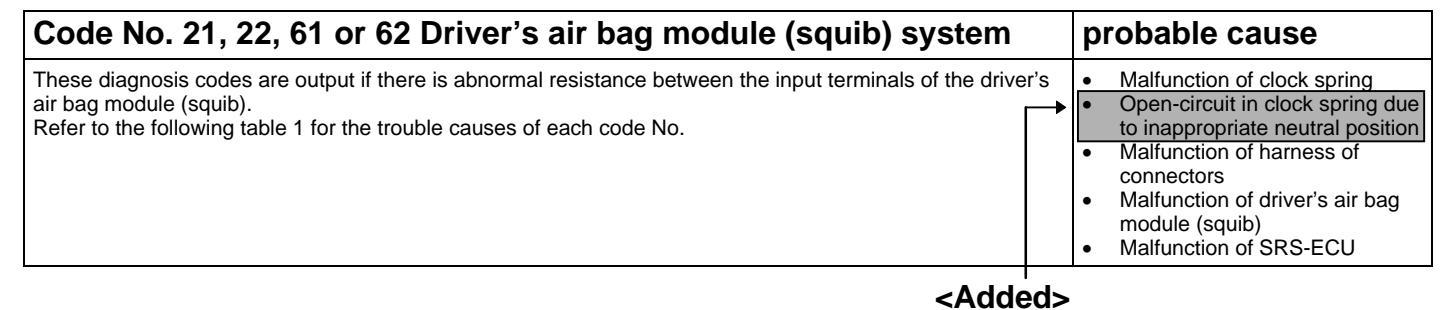
Code No. 21 or 22 Driver's side air bag module (squib) system	Probable cause	
These diagnosis codes are output if there is abnormal resistance between the terminals of the safing G sensor. The cause of the problem is probably a short-circuit in the safing G sensor.	<ul> <li>Malfunction of clock spring <added></added></li> <li>Open-circuit in clock spring due to inappropriate neutral position.</li> <li>Malfunction of harness or connectors</li> <li>Malfunction of driver's side air bag module (squib)</li> <li>Malfunction of SRS-ECU</li> </ul>

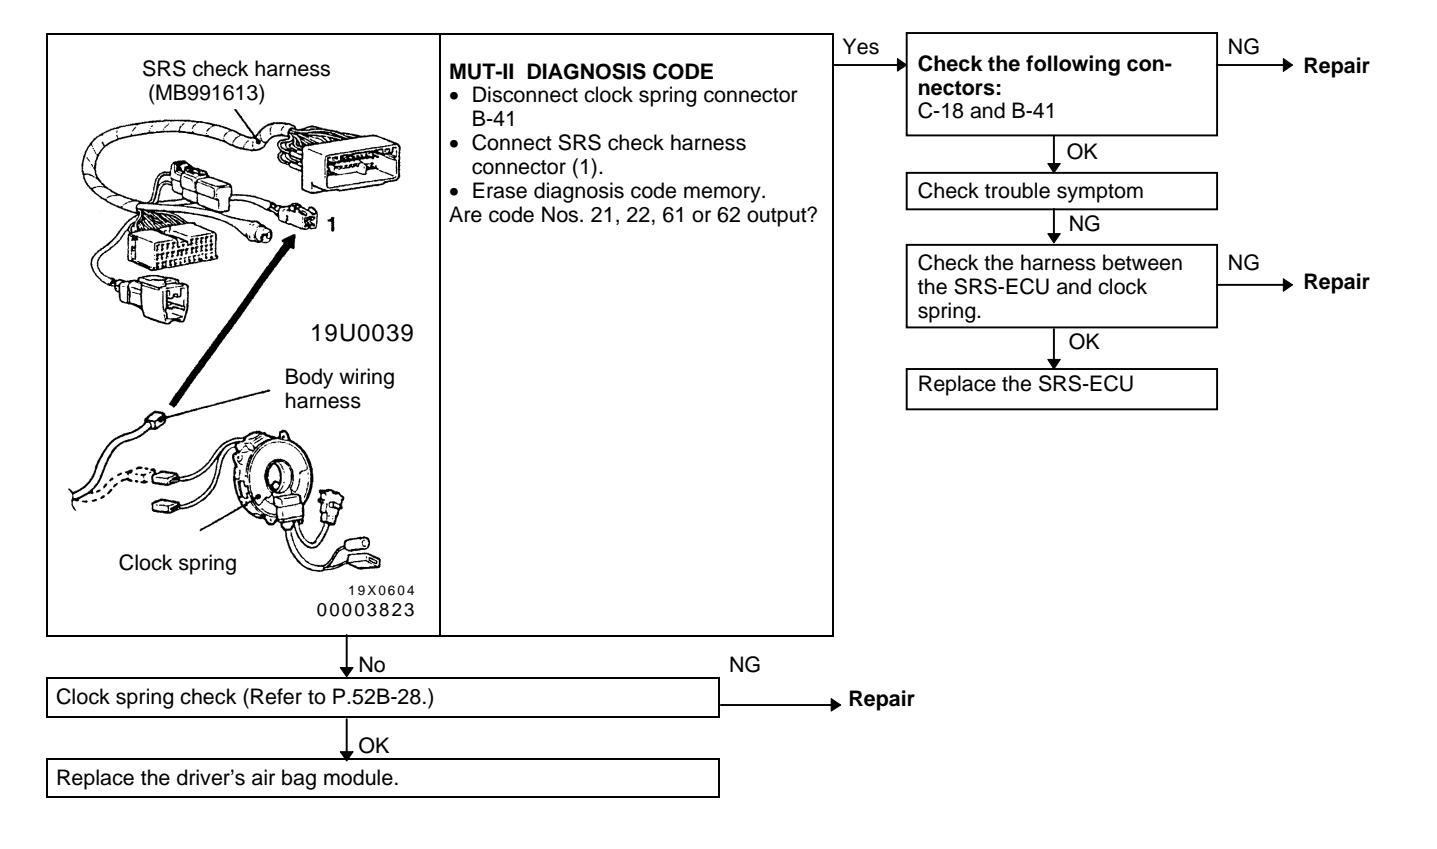
#### Chart 1

Code No.	Trouble symptom	
21	<ul> <li>Short in driver's side air bag module (squib) or harness short</li> <li>Short in clock spring</li> </ul>	
22	<ul> <li>Open circuit in driver's side air bag module (squib) or open harness</li> <li>Open circuit in clock spring</li> <li>Disconnected connector in the driver's side air bag module (squib)</li> <li>Open circuit in clock spring due to inappropriate neutral position</li> <li>Malfunction of connector contact</li> </ul>	<added></added>
61	The harness wire of the driver's air bag module (squib) is grounded to the power supply.	
62	The harness wire of the driver's air bag module (squib) is grounded.
