# SERVICE BULLETIN

<b>SERVICE BULLETIN</b>		No.: ESB-97E51-501	
		Date: 1998-03-15	<Model> <M/Y>
<b>Subject:</b>	CENTER CONSOLE PANEL AND CUP HOLDER REMOVAL	(EC,EXP) CARISMA	96-10
<b>Group:</b>	INTERIOR		
<b>CORRECTION</b>

This Service Bulletin informs you of addition of a removal procedure for the center console panel and cup holder assembly

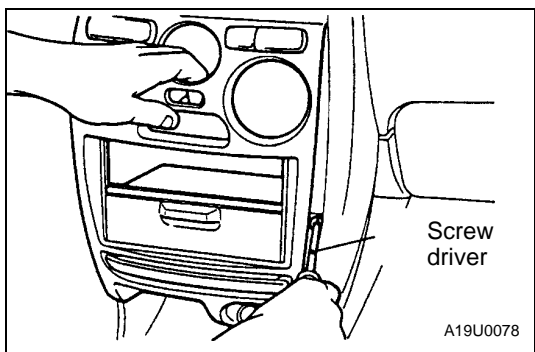
**◀ A ▶ CENTER CONSOLE PANEL AND CUP HOLDER ASSEMBLY REMOVAL**

- ▶ 1. After removing the center console mounting screws, pull the center console panel towards you to remove it together with the cup holder, inner
- ▶ 2. Insert a screwdriver into the space as shown in the illustration to remove the center console panel and cup holder assembly

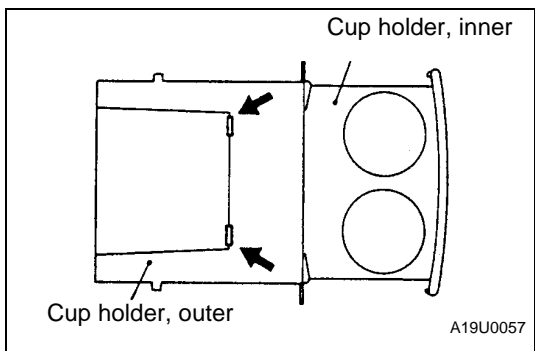
**◀ B ▶ CUP HOLDER, INNER REMOVAL**

Push the cup holder, outer in the places shown in the illustration to remove the cup holder, inner.

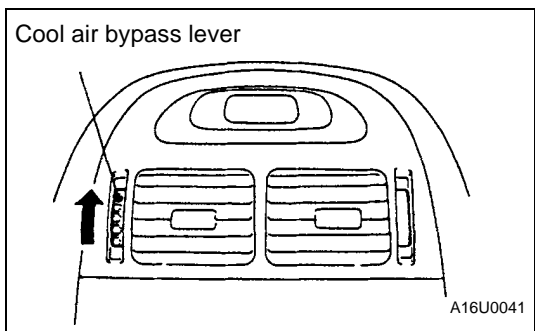
**▶ A ◀ CENTER AIR OUTLET ASSEMBLY INSTALLATION**

1. Turn the cool air bypass lever of the center air outlet assembly fully upward.
2. Turn the cool air bypass damper at the heater unit side fully downward, and install the cool air bypass lever cable.

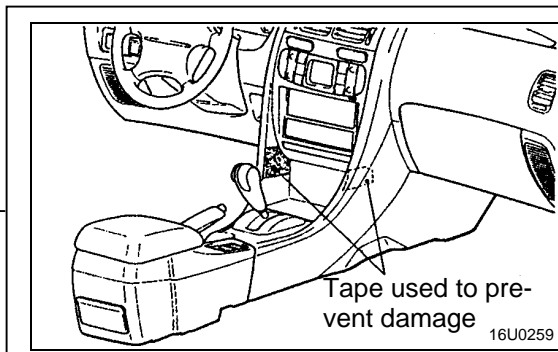
1. Affix a tape to the front floor console assembly to prevent it from being damaged.
